June 23, 2023

**Re: Retention Wall Inspection Report for Placido Bayou at  
4691 Laurel Oak Lane NE, St. Petersburg, FL 33703**

REUBEN CLARSON CONSULTING, INC.

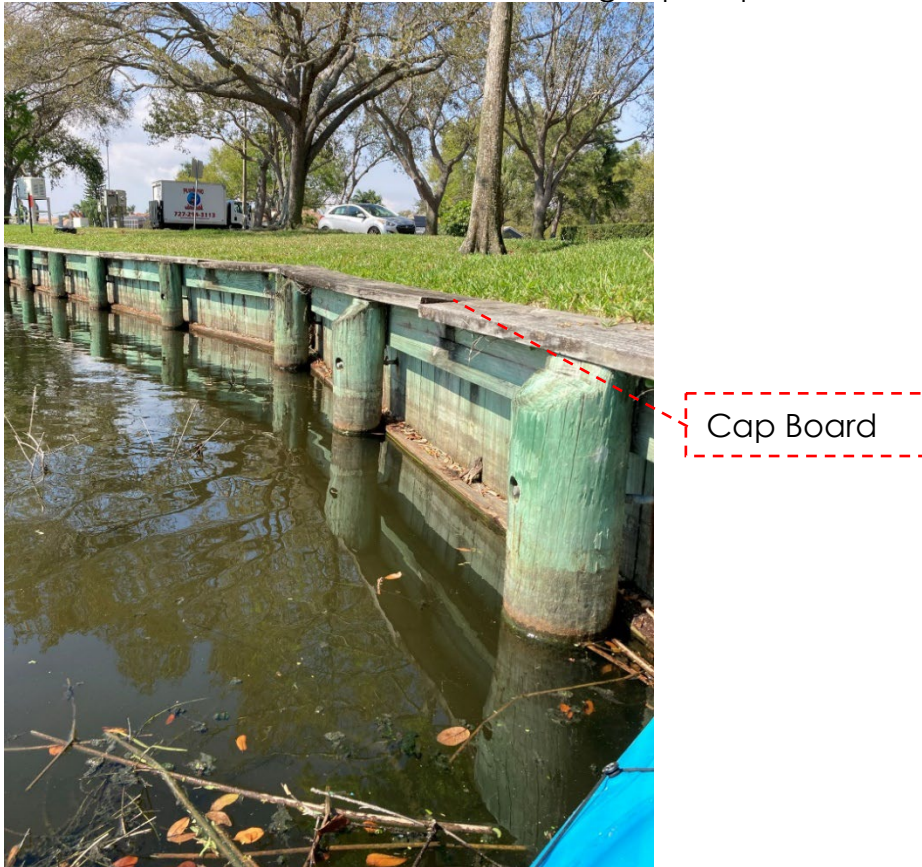
Photo 1: View of Deteriorated/Cracking Top Cap

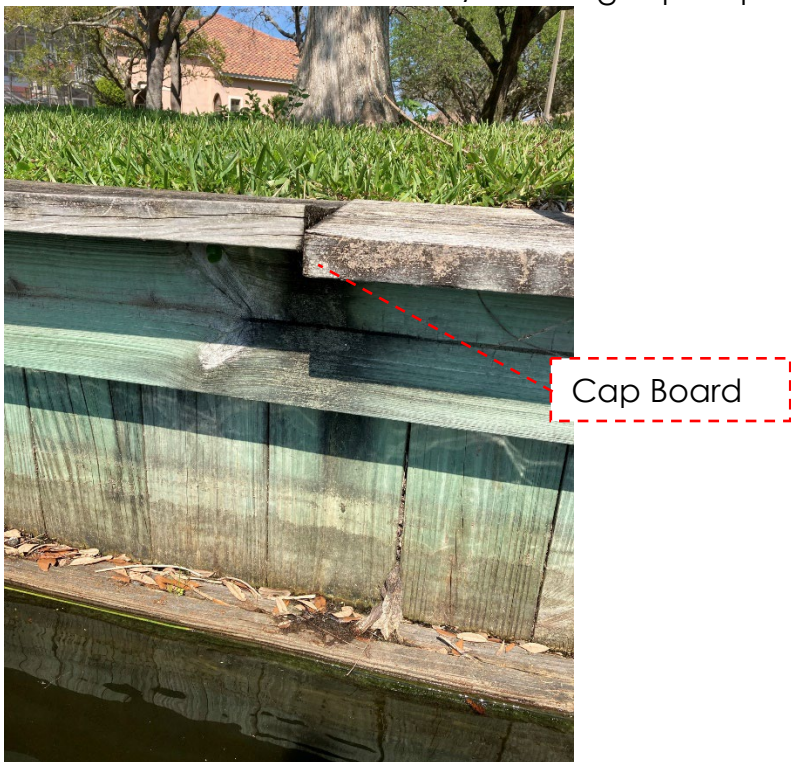
Photo 2: View of Deteriorated/Cracking Top Cap

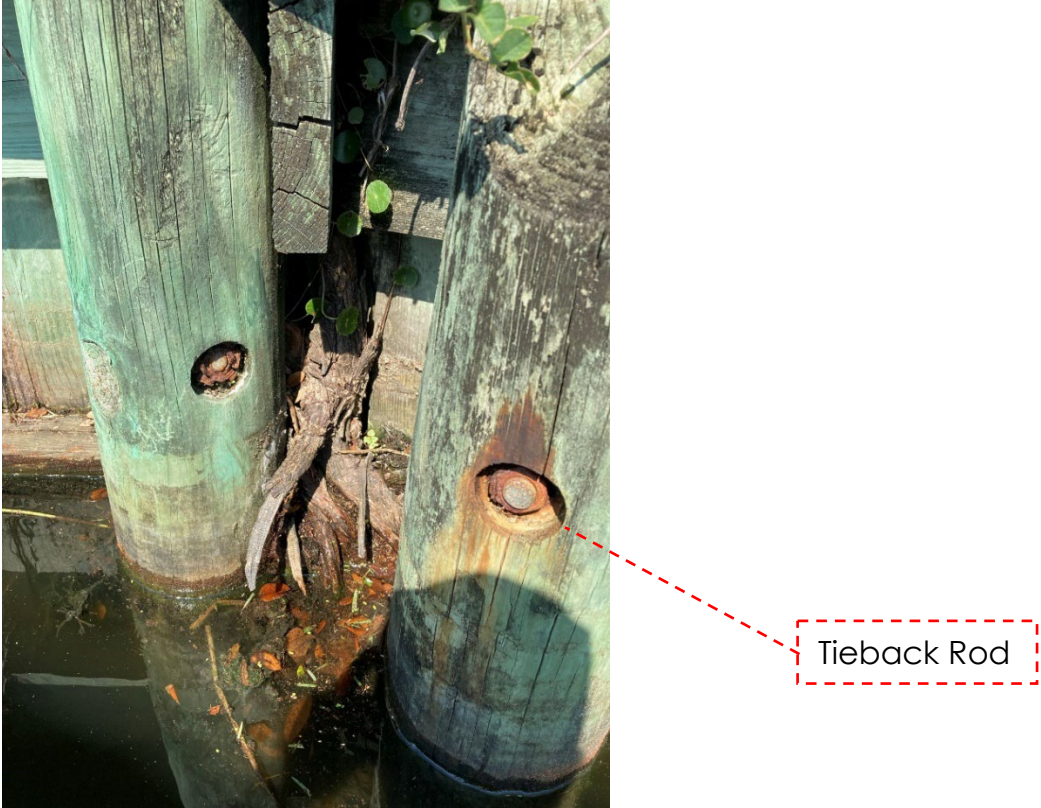
Photo 3: View of Corroded Tieback Rods

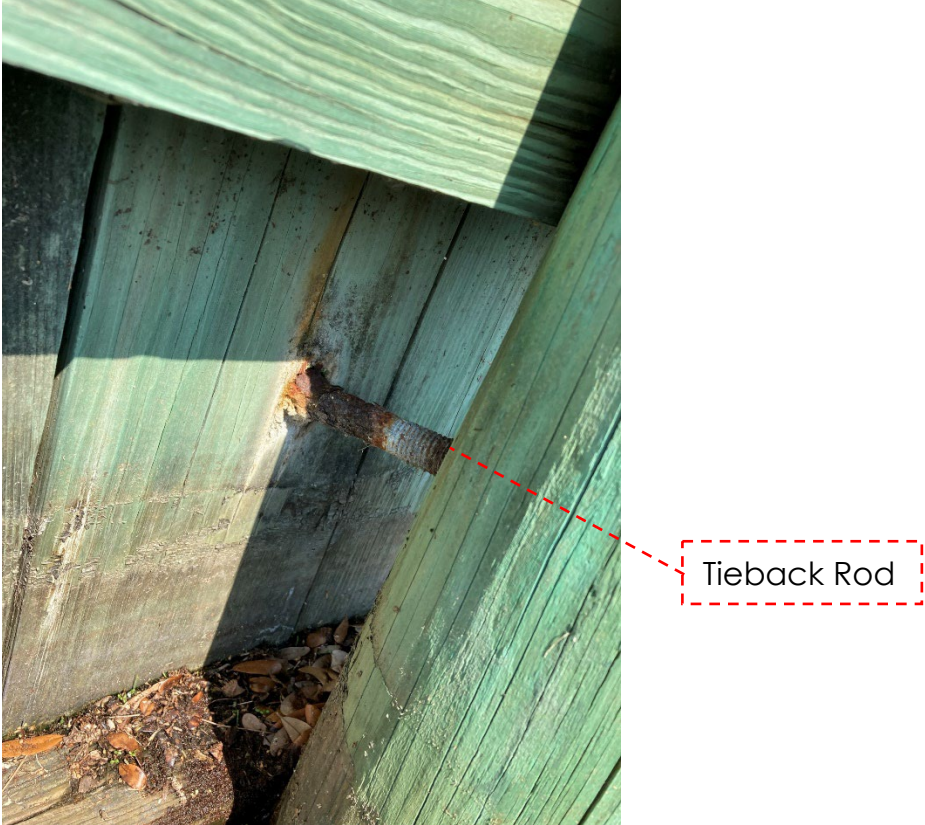
Photo 4: View of Corroded Tieback Rods

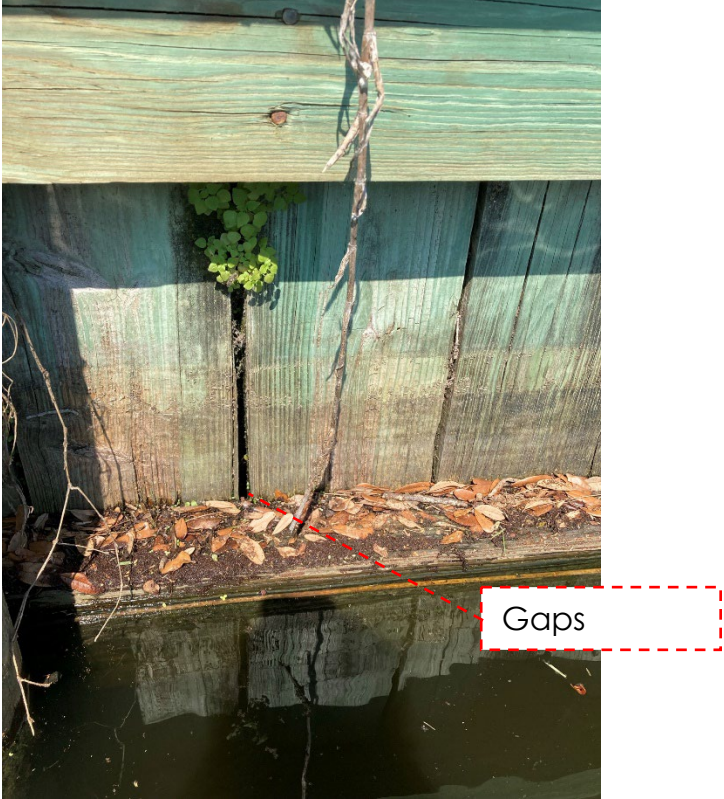
Photo 5: View of Gaps Between Vertical Boards

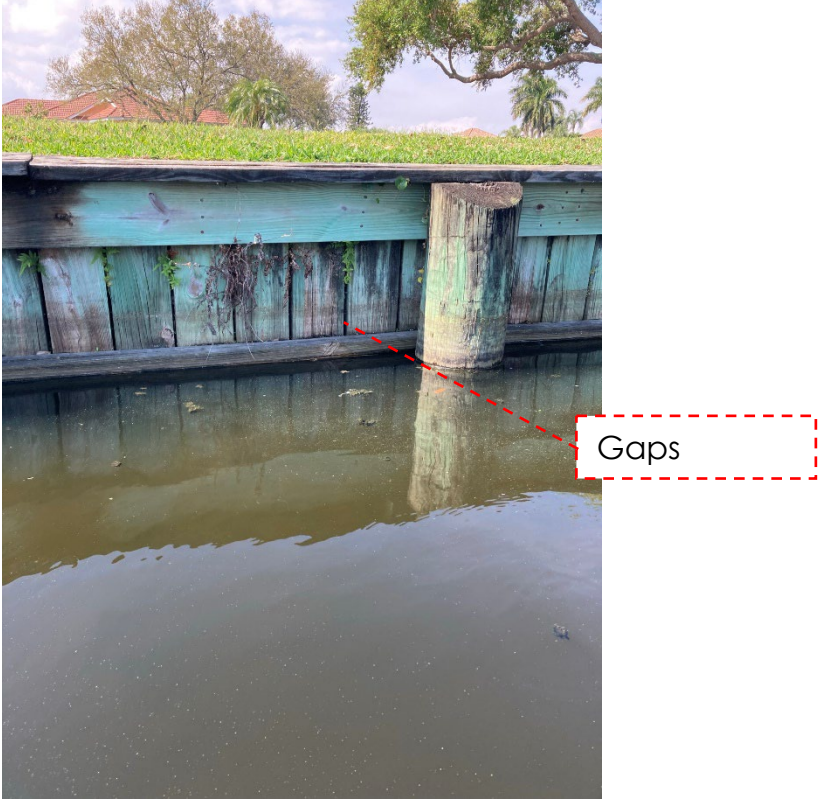
Photo 6: View of Gaps Between Vertical Boards

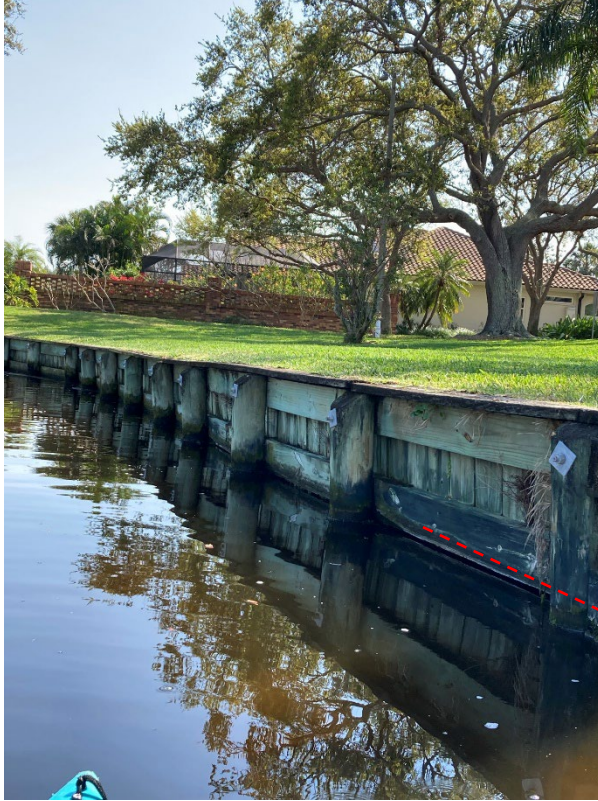
Photo 7: View of Bowing Walers and Leaning Wall in Pond #9

Bowing Waler

**Pond #9:** Replacement of existing wood wall. (460 LF x \$500/LF= \$230,000)

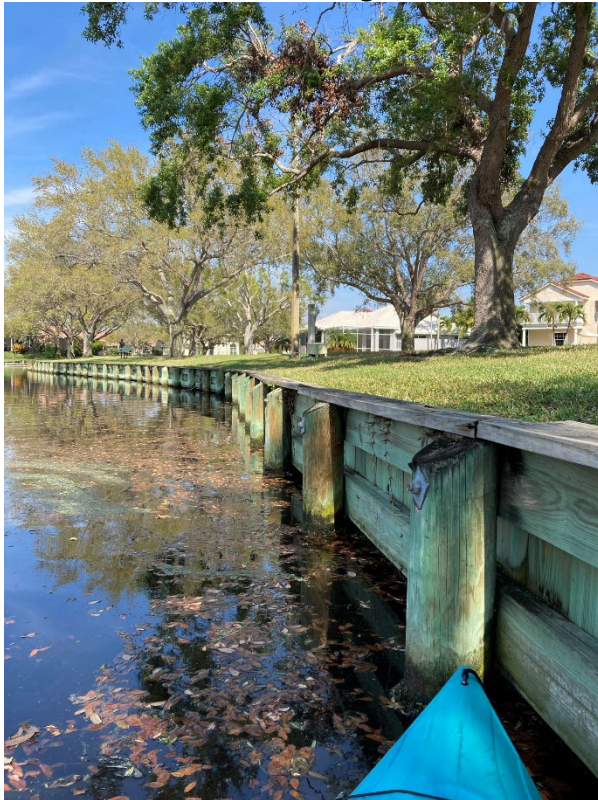
Photo 8: View of Bowing Walers and Leaning Wall in Pond #9

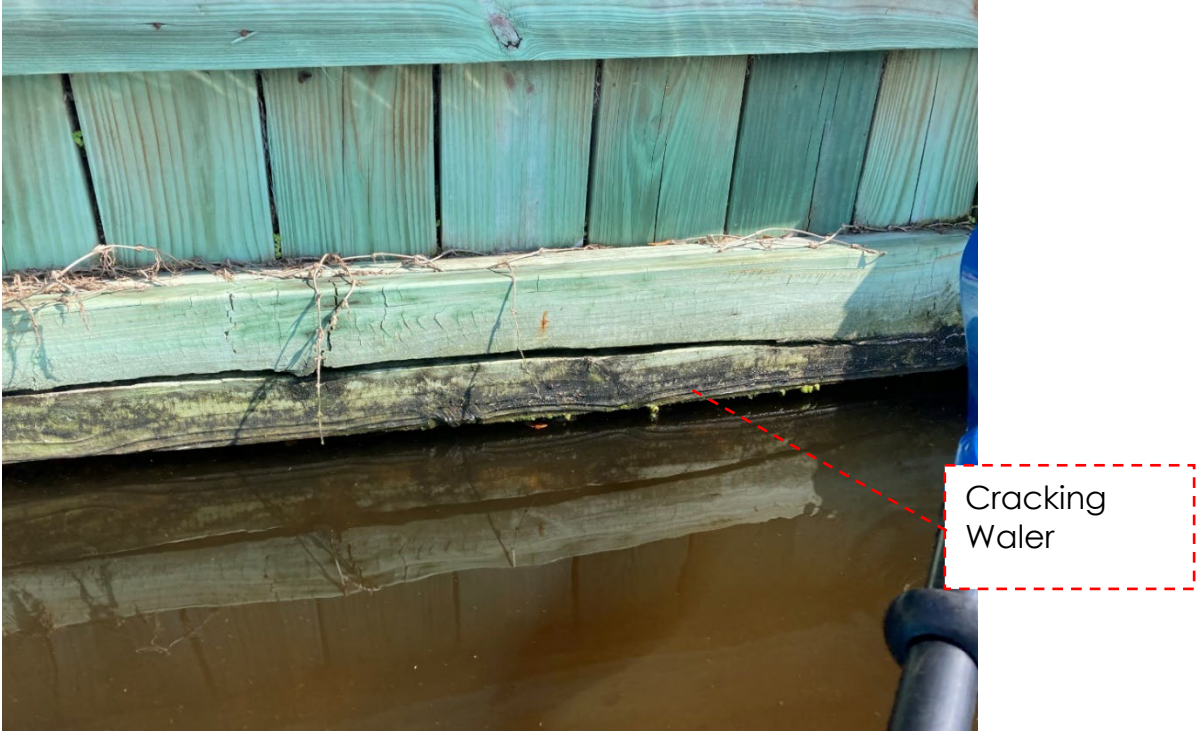
Photo 9: View of Cracking Walers and Leaning Wall in Pond #9

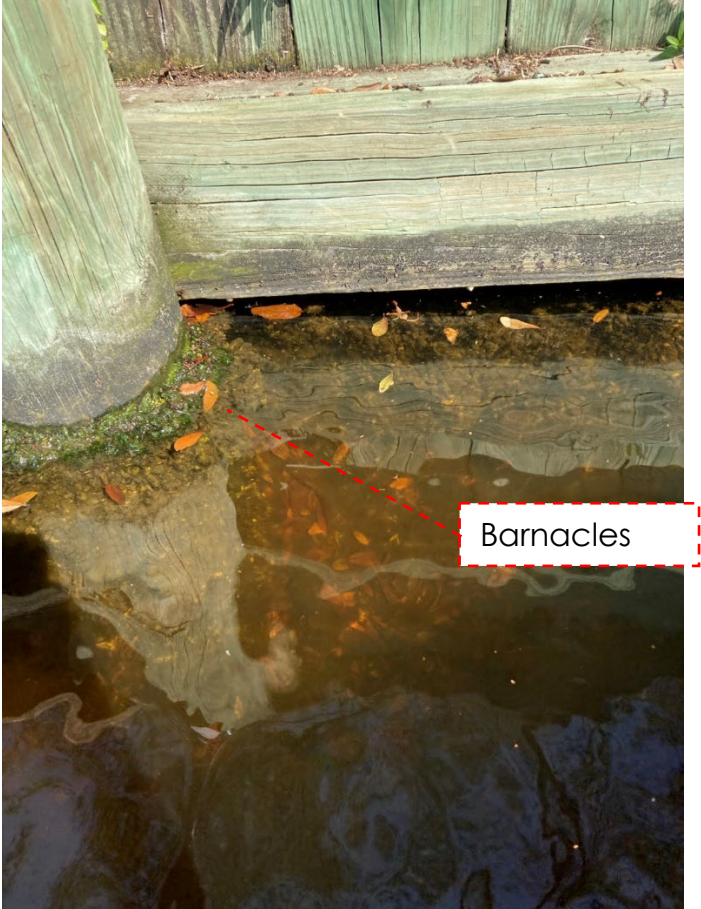
Photo 10: View of Holes in Bottom of Vertical Wall in Pond #9.
