Placido Bayou Community Association Waterway Inspection Report

Reason for Inspection:
Quality Assurance

Inspection Date:
6/27/2024

Prepared for:
Placido Bayou
Community Association

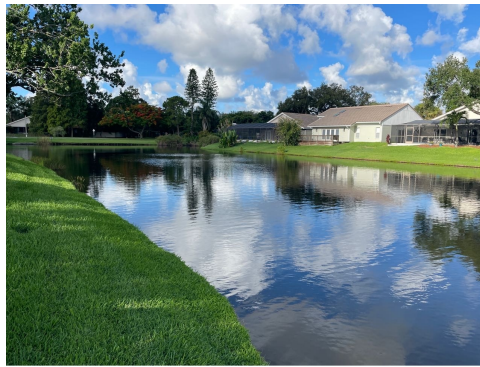
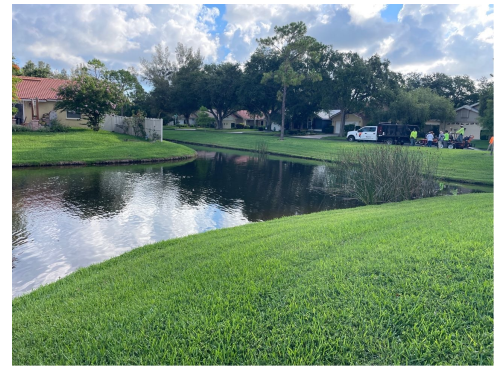
Pond 1

Normal Growth Observed

Continue treatment of Algae and Torpedograss along the edge of the pond.

Widgeon grass has made its way into the pond. Successful contact treatments have been applied to gain control of this submersed aquatic.

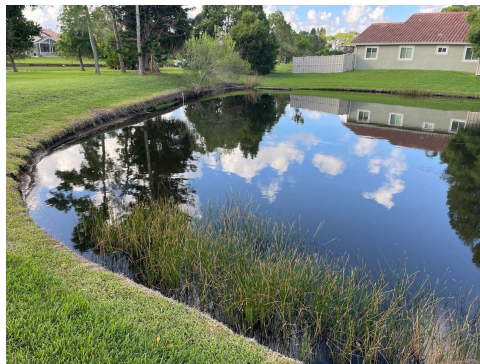
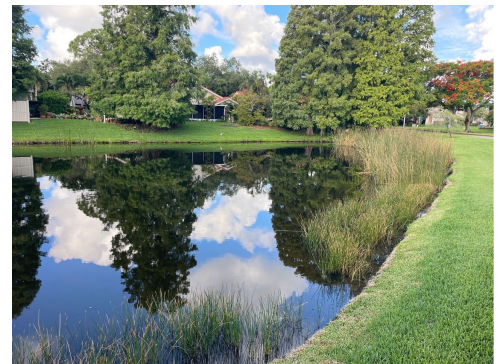
Pond 2

Normal Growth Observed

Continue treatment of Torpedograss along the edge of the pond.

Widgeon grass has made its way into the pond. Treatments have been performed in late June and early July to gain control of this submersed aquatic. Several diffusers in this pond are still not functioning. Tom serviced on July 2nd and is returning the week of 7/15/-7/19 to inspect and perform additional repairs.

Several diffusers in ponds 2 & 7 are still not functioning as of 7/12/24. Tom serviced on July 2nd and is returning the week of 7/15/-7/19 to inspect and perform additional repairs until all diffusers are working properly.

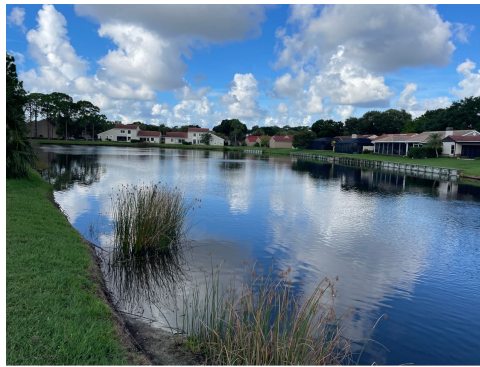
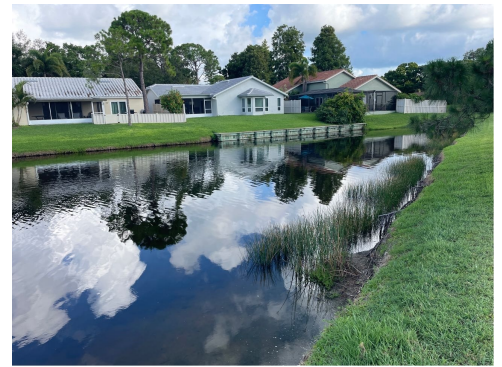
Pond 3

Normal Growth Observed

Torpedograss, algae and alligator weed have been targeted along the ponds edge and at the base of the wood retaining wall.

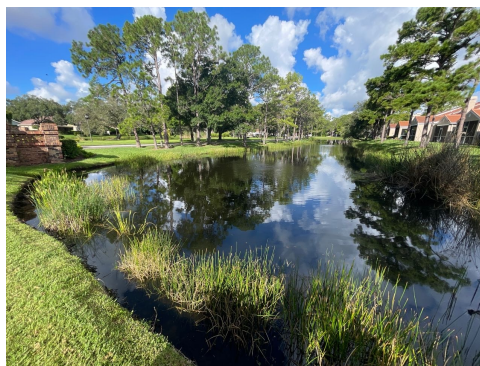
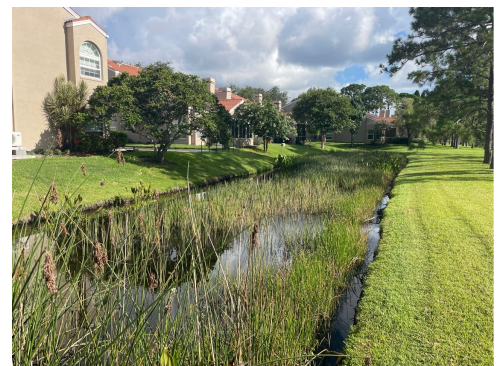
Pond 4

Normal Growth Observed

We continue to carefully spot treat alligator weed and Torpedograss within the pond and around the native aquatic plants.

Bacterial enzymes and oxidizers are applied to the pond periodically.

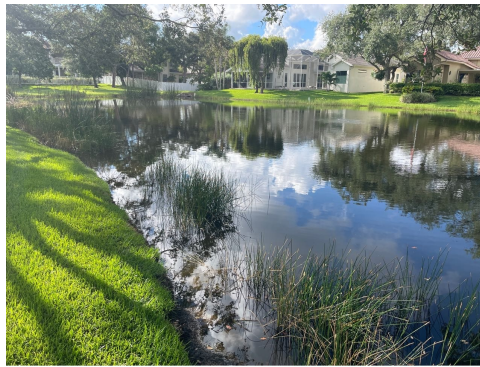
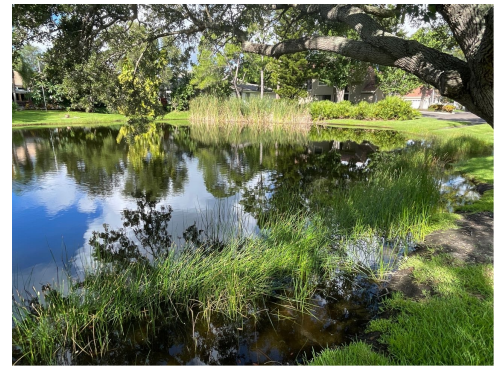
Pond 5

Site Looks Good

Treatment of Torpedograss and alligator weed is being performed within and around the native aquatic plants.

Native Spikerush is healthy.

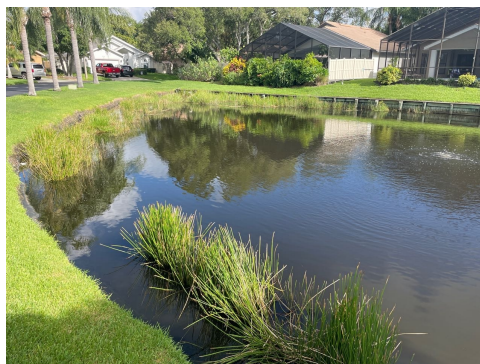
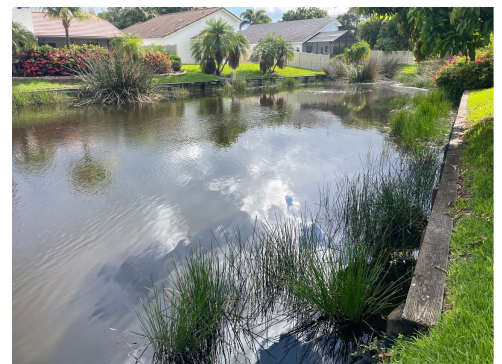
Pond 6

Site Looks Good

We continue to carefully spot treat alligator weed and Torpedograss within the pond and around the native aquatic plants.

Bacterial enzymes and oxidizers are applied to the pond periodically.

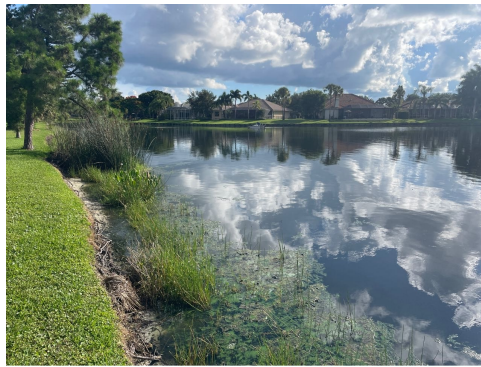
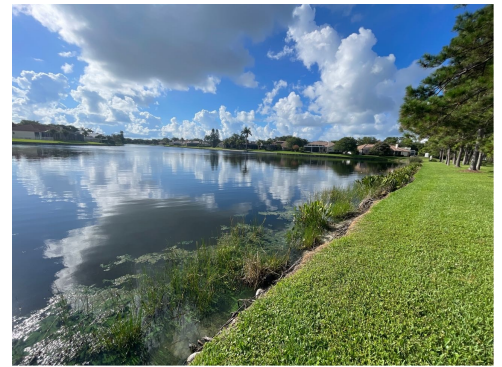
Pond 7

Treatment In Progress

Boat is being used monthly to apply algicide, Biozyme Nitrifier, and contact aquatic herbicides to the pond. Follow up algae treatments are performed via ATV two weeks after boat application. We are increasing the algicide and Biozyme rates by 50% immediately until the high air and water temps are lower in Nov-Dec. The prominent algal growth present is green algae, not blue green algae, which is positive.

As expressed earlier, a boat is being utilized monthly to apply copper based algicide, Biozyme, and contact aquatic herbicides to pond 7. Follow up algae treatments are performed via ATV two weeks after boat application.

Effective immediately, we are increasing the algicide and Biozyme rates by 50% until the high air and water temps are lower in Nov-Dec. Biozyme Nitrifiers are specialized, highly concentrated, powerful bacteria that attack ammonia and nitrate, and also help to bind phosphates.

This strategy will produce better control of the algal growth within pond 7. Of course, we will ensure that we do not exceed legal limits of algicide and aquatic herbicide usage.

We certainly understand the homeowners' concerns regarding the swarming adult Midge Flies around pond 7. We're doing everything we can from an algae treatment perspective since algae is just one of the food sources for the Midge Fly larvae.

Application of larvicides can be performed in the form of 3 applications in the mid-late Summer and 3 applications repeated in the early Spring. These applications are time consuming since each treatment has to cover the entire acreage of the pond in a concentric circle pattern applied every 20' around the pond. The cost for each 3 treatment sequence will be \$8,950.

The longer term strategy for assisting in control of Midge Flies would entail the stocking of additional predatory fish to feed on the Midge Fly at the larval stage. The recommended fish are- 2,000 2" Bluegill, 4,500 2" Shellcrackers (Redears) & 6,500 4" Channel Catfish. These predatory fish feed on the Midge Flies at the larval and pupation stages. The cost for this stocking will be \$14, 625.

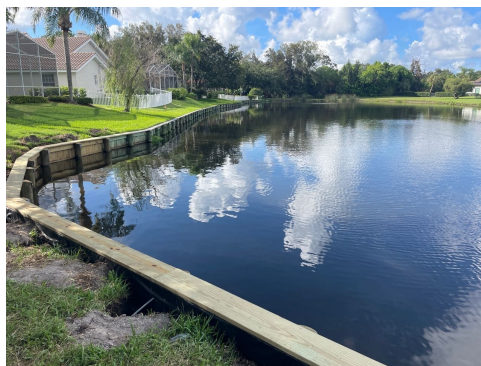
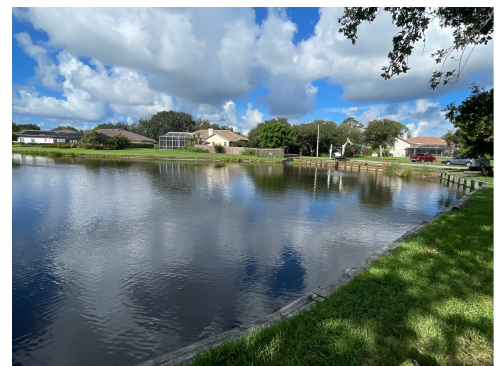
Pond 8

Normal Growth Observed

Minimal amounts of Algae and Torpedograss observed and treated.

Wood retaining wall is in the process of being repaired.

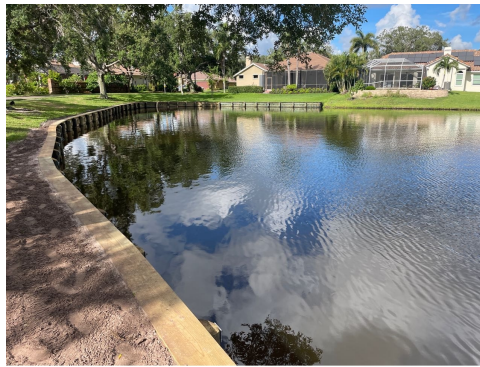
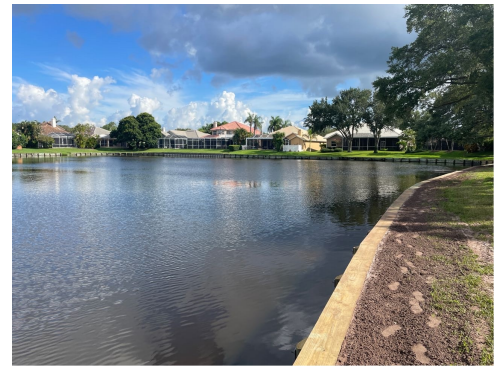
Pond 9

Treatment In Progress

Wood retaining wall has been sprayed free of Torpedograss and weeds.

Wall recently repaired.

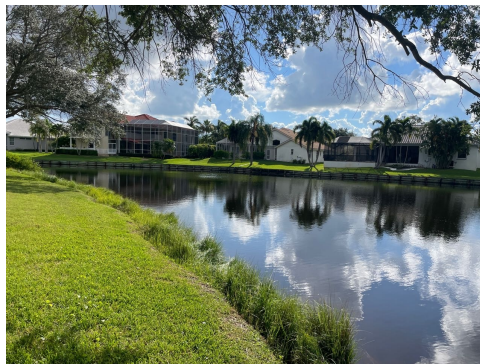
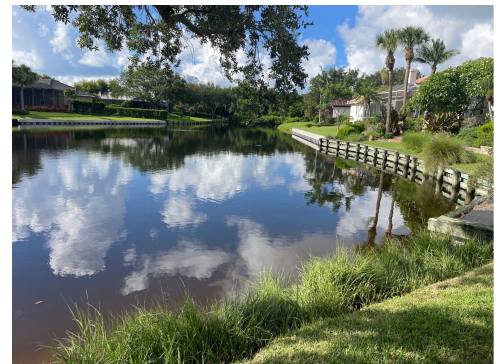
Pond 10

Site Looks Good

Wood retaining walls have been sprayed free of Torpedograss and weeds.

Shoreline native aquatic plants are healthy and helping to naturally stabilize the shoreline area.
